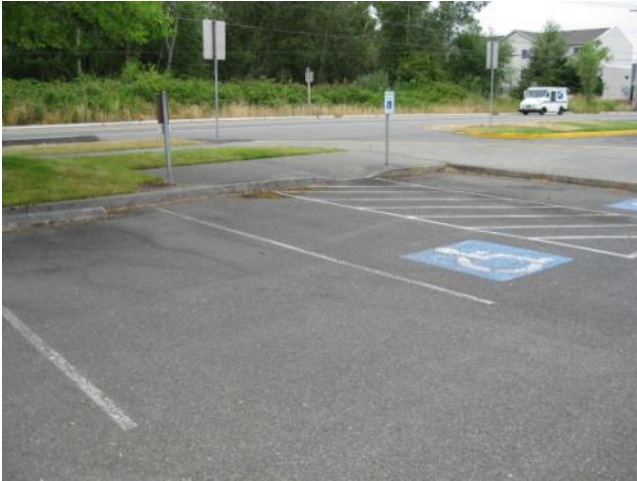
**LH-SI-01 ACCESSIBLE PARKING STALL ADDITION**

An additional parking stall is needed for disabled individuals and to meet ADA requirements.

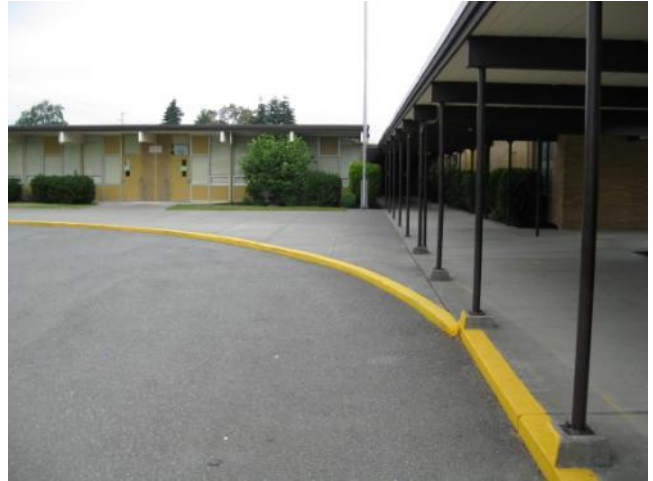
**LH-SI-10 CURB RAMP ADDITION**

A curb ramp is needed at the front entry for wheelchair access and to meet ADA requirements.

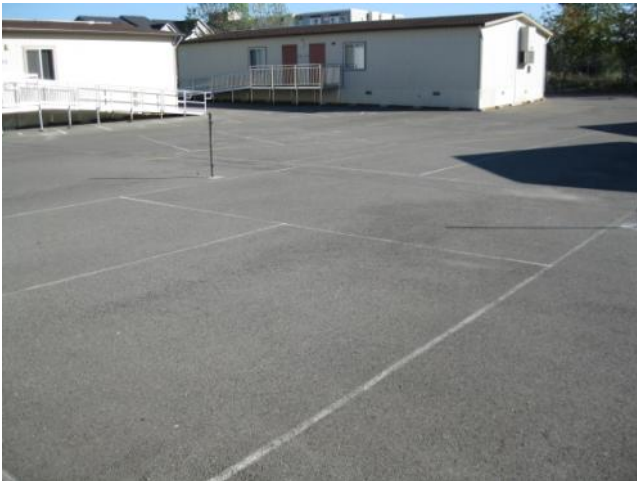
**LH-SI-20 PLAYGROUND MARKING UPGRADE**

New pavement markings needed for playground game lines.

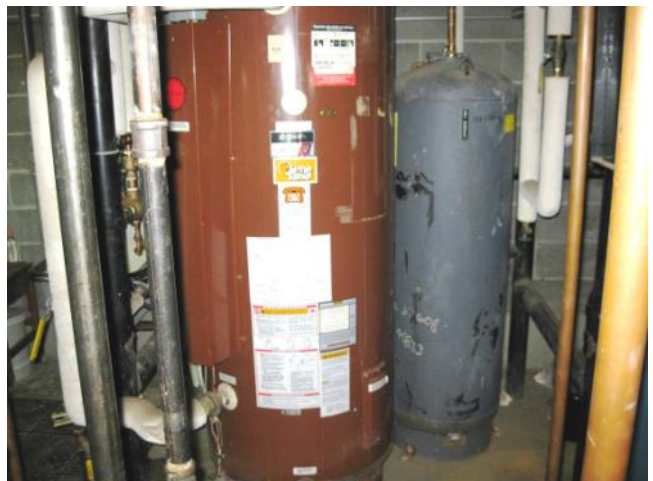
**LH-ST-07 MECHANICAL EQUIPMENT ANCHORING**

Mechanical equipment needs to be anchored in place for seismic support.

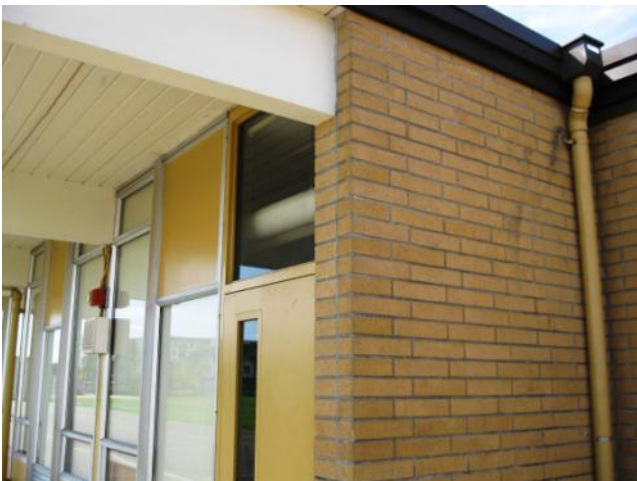
**LH-ST-09 MASONRY WALL CRACK REPAIR**

Masonry repair needed at cracks in exterior walls to protect walls from water infiltration and structural damage.

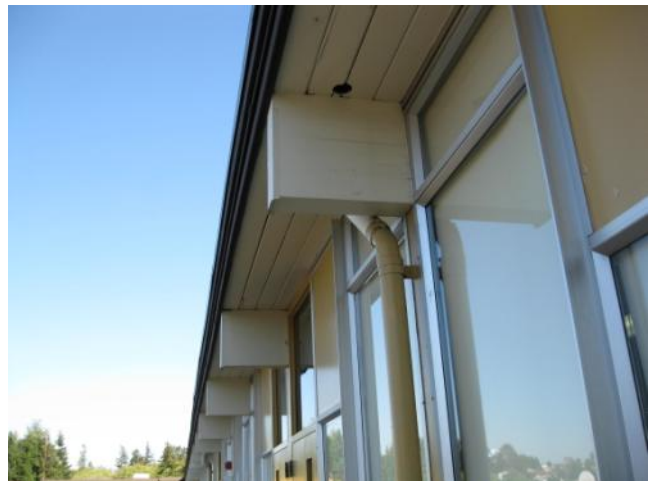
**LH-ST-11 BEAM DRY ROT REPAIR**

Repair of dry rot at exterior wood beams needed to protect against further damage and deterioration.

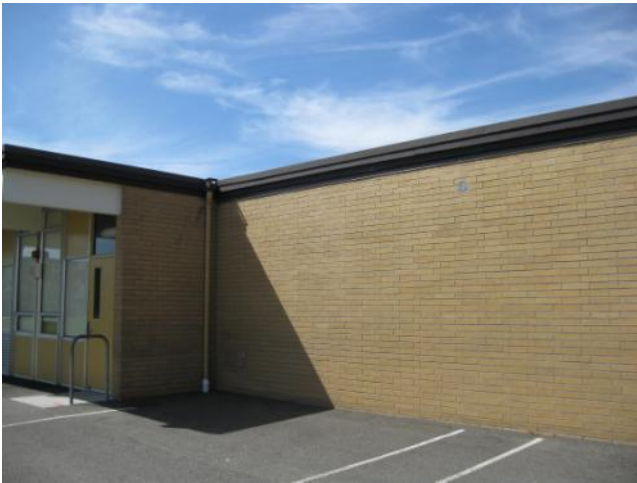
**LH-ST-12 BRICK REPLACEMENT**

Repair of brick at exterior masonry wall at 400 Unit needed to protect wall from water infiltration and structural damage.

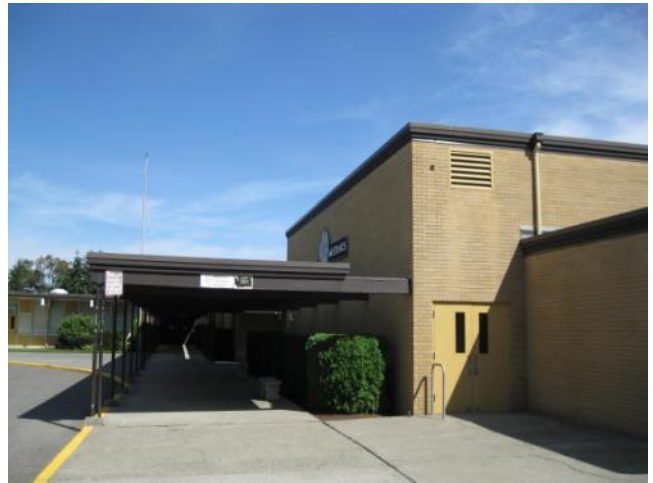
**LH-ST-13 MORTAR JOINT REPAIR**

Masonry repair needed at mortar joints at Gym to protect walls from water infiltration and structural damage.

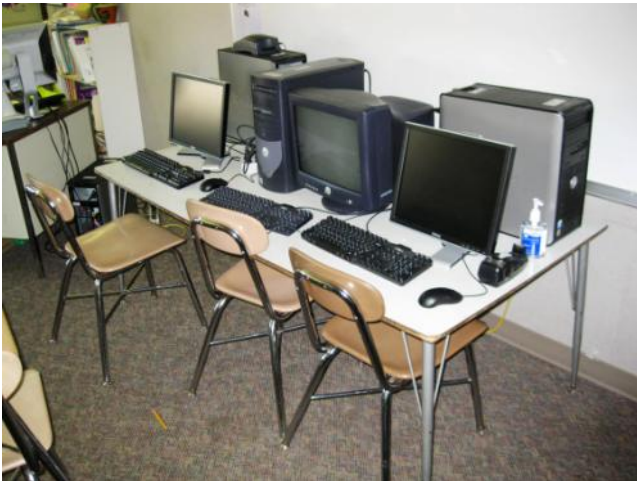
**LH-EQ-01 COMPUTER FURNITURE UPGRADE**

Computer furniture needed to properly accommodate students and computer equipment.
